**ORNL**  
**CENTRAL FILES NUMBER**

60-9-57

DATE: January 10, 1961

SUBJECT: Plutonium Release Incident at Oak Ridge National Laboratory\*

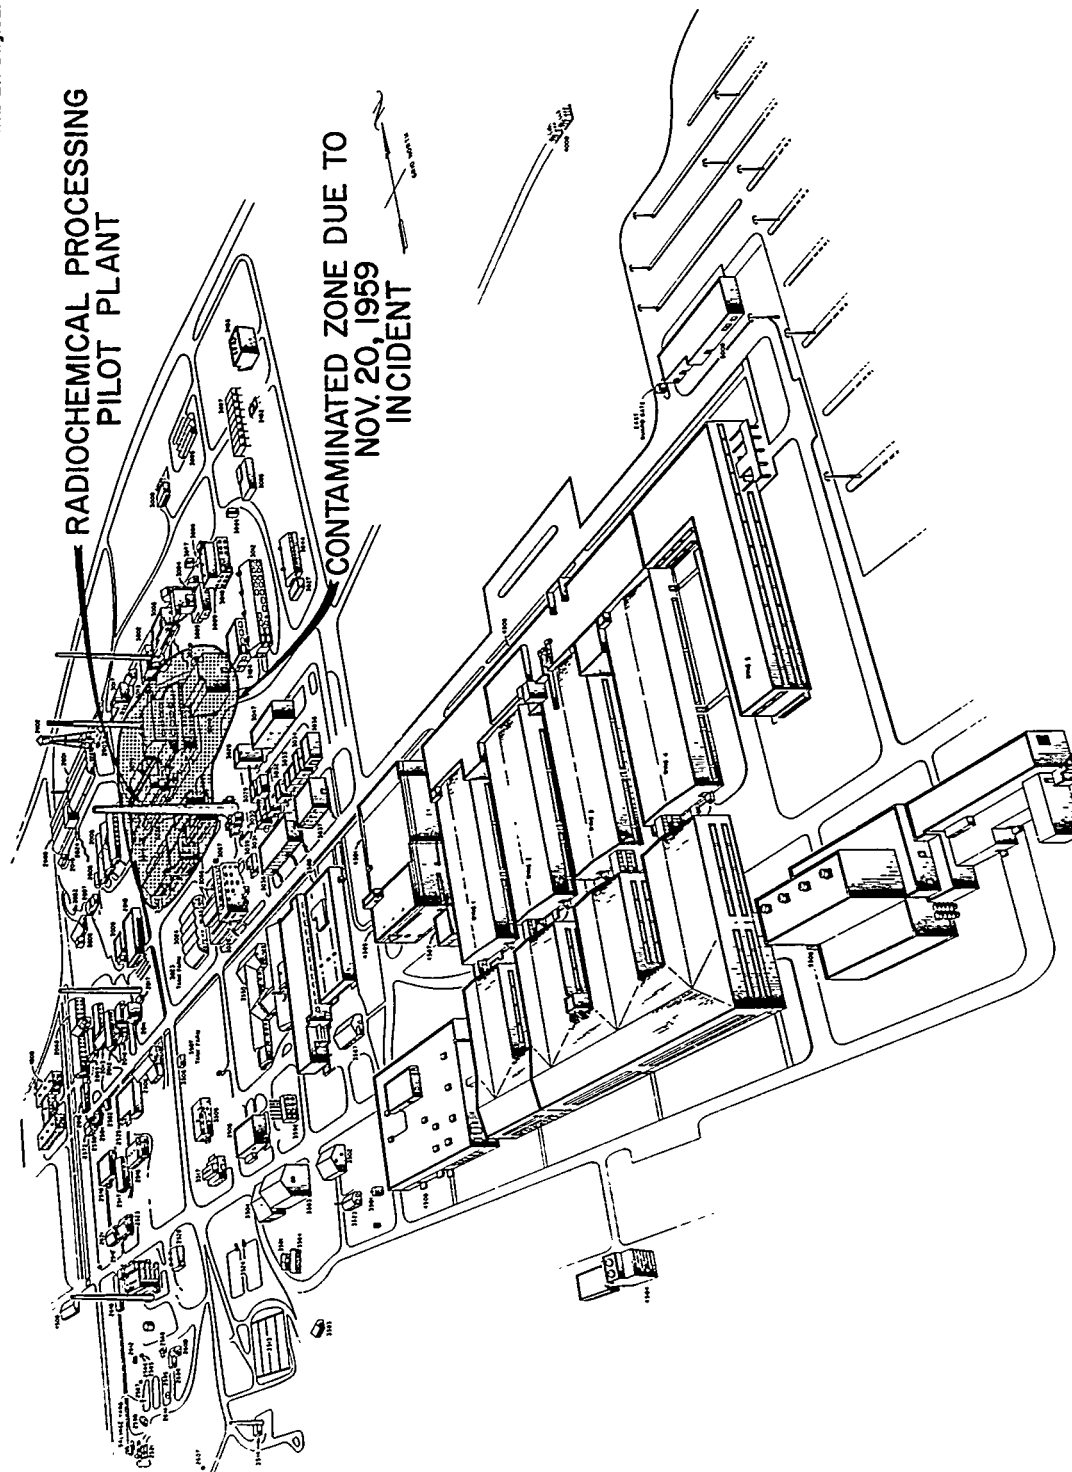
Fig. 3. Oak Ridge National Laboratory,  
X-10 Site

Figure 3 is a map of the Laboratory which shows the Radiochemical Processing Pilot Plant and the portion of the Laboratory which was involved in the fall-out. Figure 4 is an enlargement of the affected area. Contamination in some areas was more than 100,000 disintegrations per minute per 100 sq cm. This is about one bpd burden of plutonium per 100 sq cm.
